THE **BOEING** COMPANY
AERO-SPACE DIVISION
LAUNCH SYSTEMS BRANCH

DOCUMENT NO. T5-6539-82

TITLE THRUST RING SPLICE ANGLE INVESTIGATION

MODEL NO. SAT V/S-IC CONTRACT NO. NAS8-5608

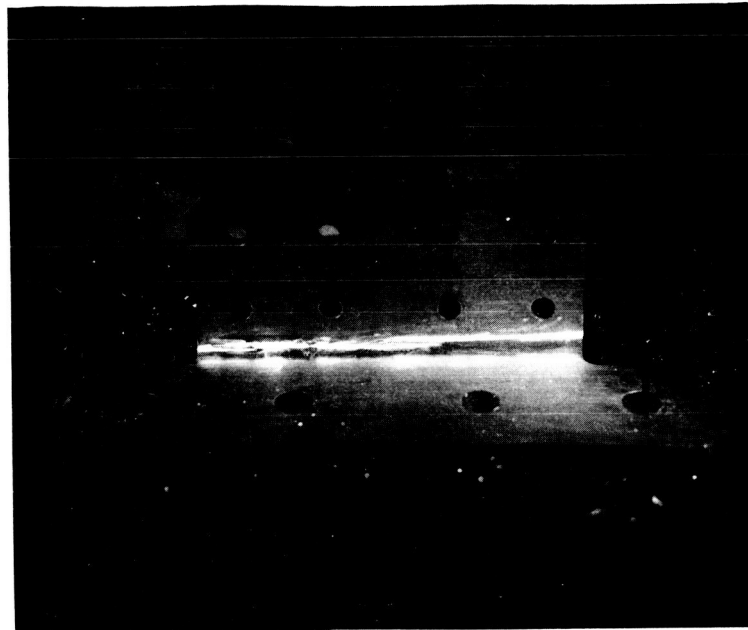
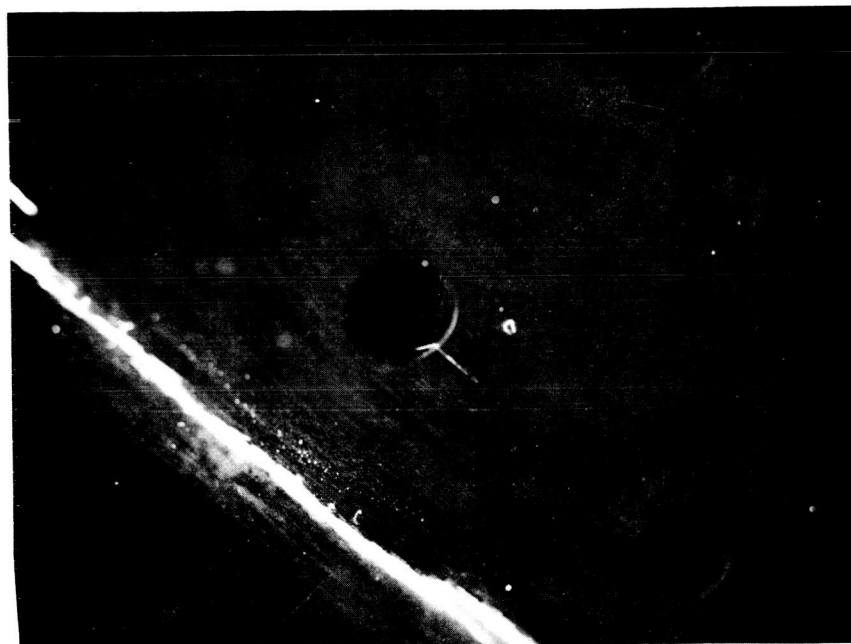
FIGURE 1

- 1) One failed angle and three unfailed angles were received by the Materials and Processes Group. All angles were stripped of any coating and penetrant inspected. Only the obviously cracked angle showed failure indications. One group of indications showed failure initiated along the back of the angle propagated through to the fillet tangent point. Another indication showed a crack initiating in a fastener hole from the back side of the angle.
- 2) Chemical analyses showed the Material to be 7075 aluminum alloy.
- 3) Tensile tests showed that mechanical properties were within specification requirements.

PHOTOGRAPHS OF PENETRANT
INDICATIONS

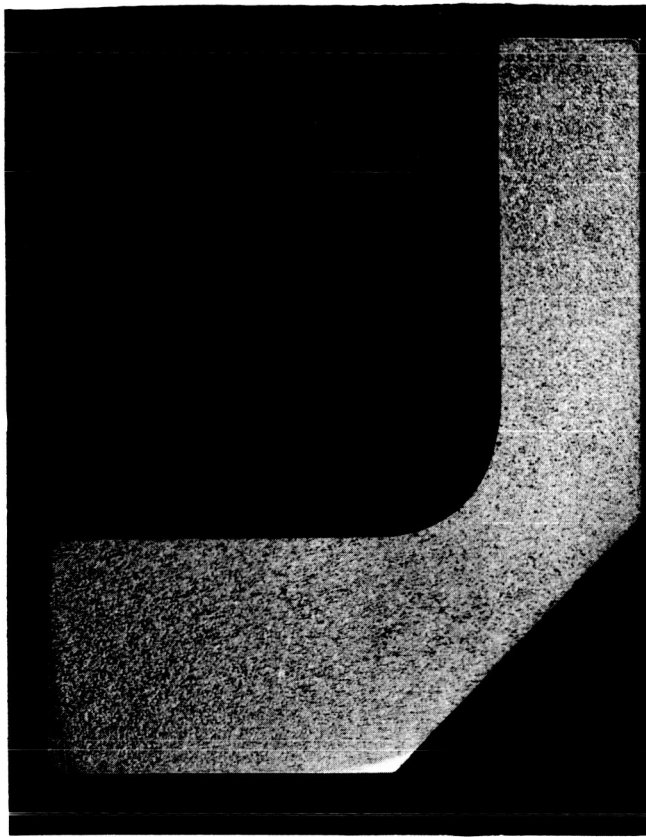
FIGURE 2 - Left

Macro Etched Cross
Section of Angle

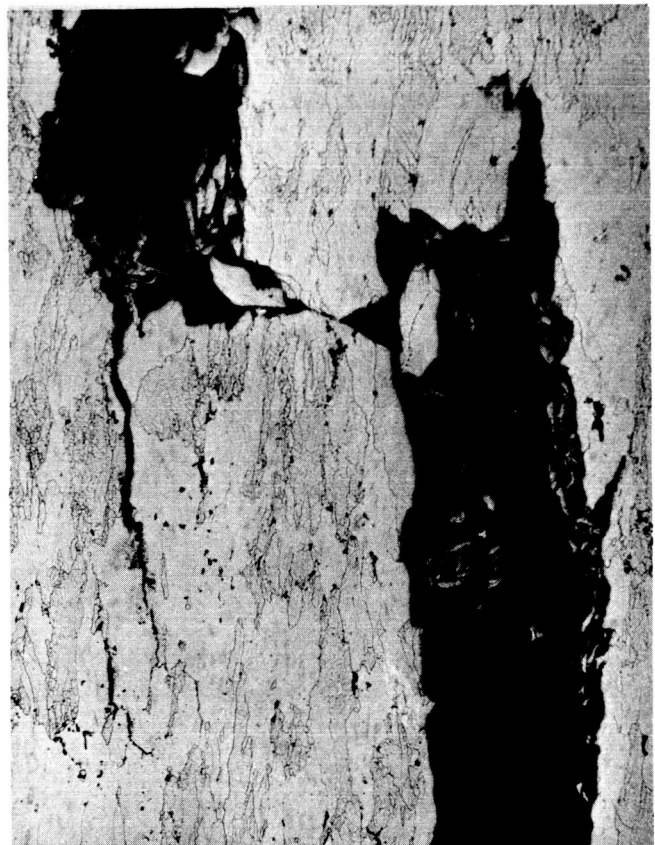
FIGURE 3 - Right

100X Photo micrograph
Showing Nature of
Cracking of Radius Failure.
Note Inter Granular Path-
way and Branching Nature
of Cracks.

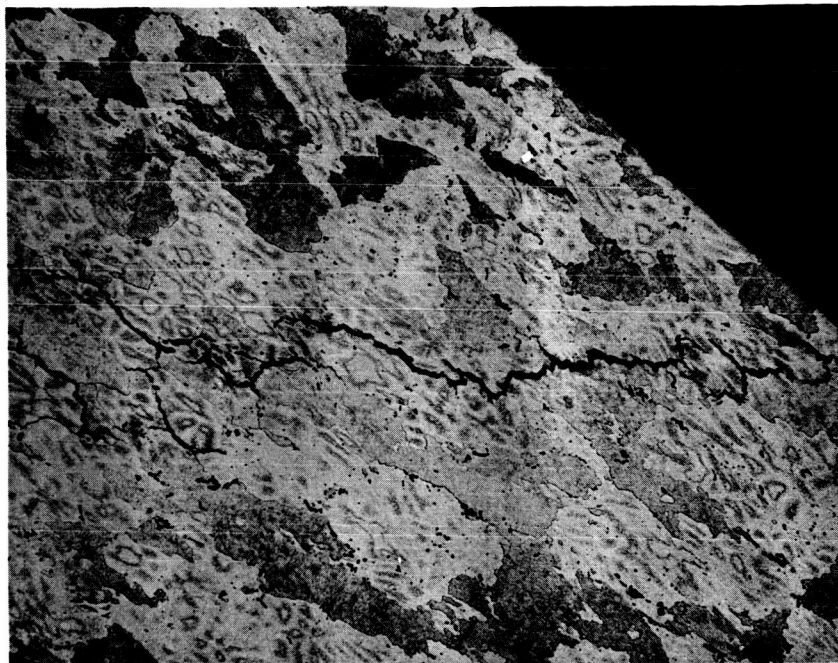
FIGURE 4

100X
PHOTO OF CROSS SECTION OF CRACK IN HOLE

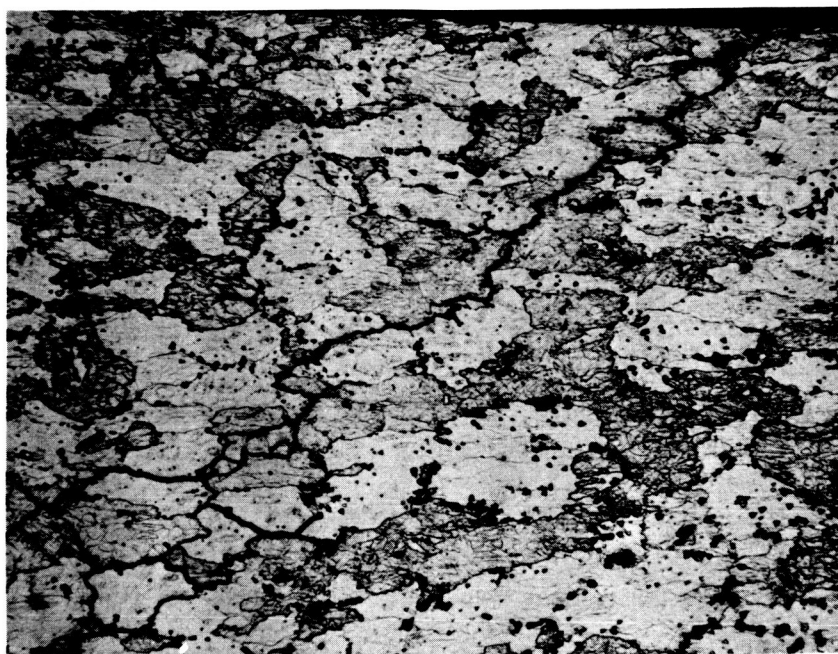
100X
PHOTO OF SAME AREA AS ABOVE WITH HEAVIER ETCH TO OUTLINE GRAINS

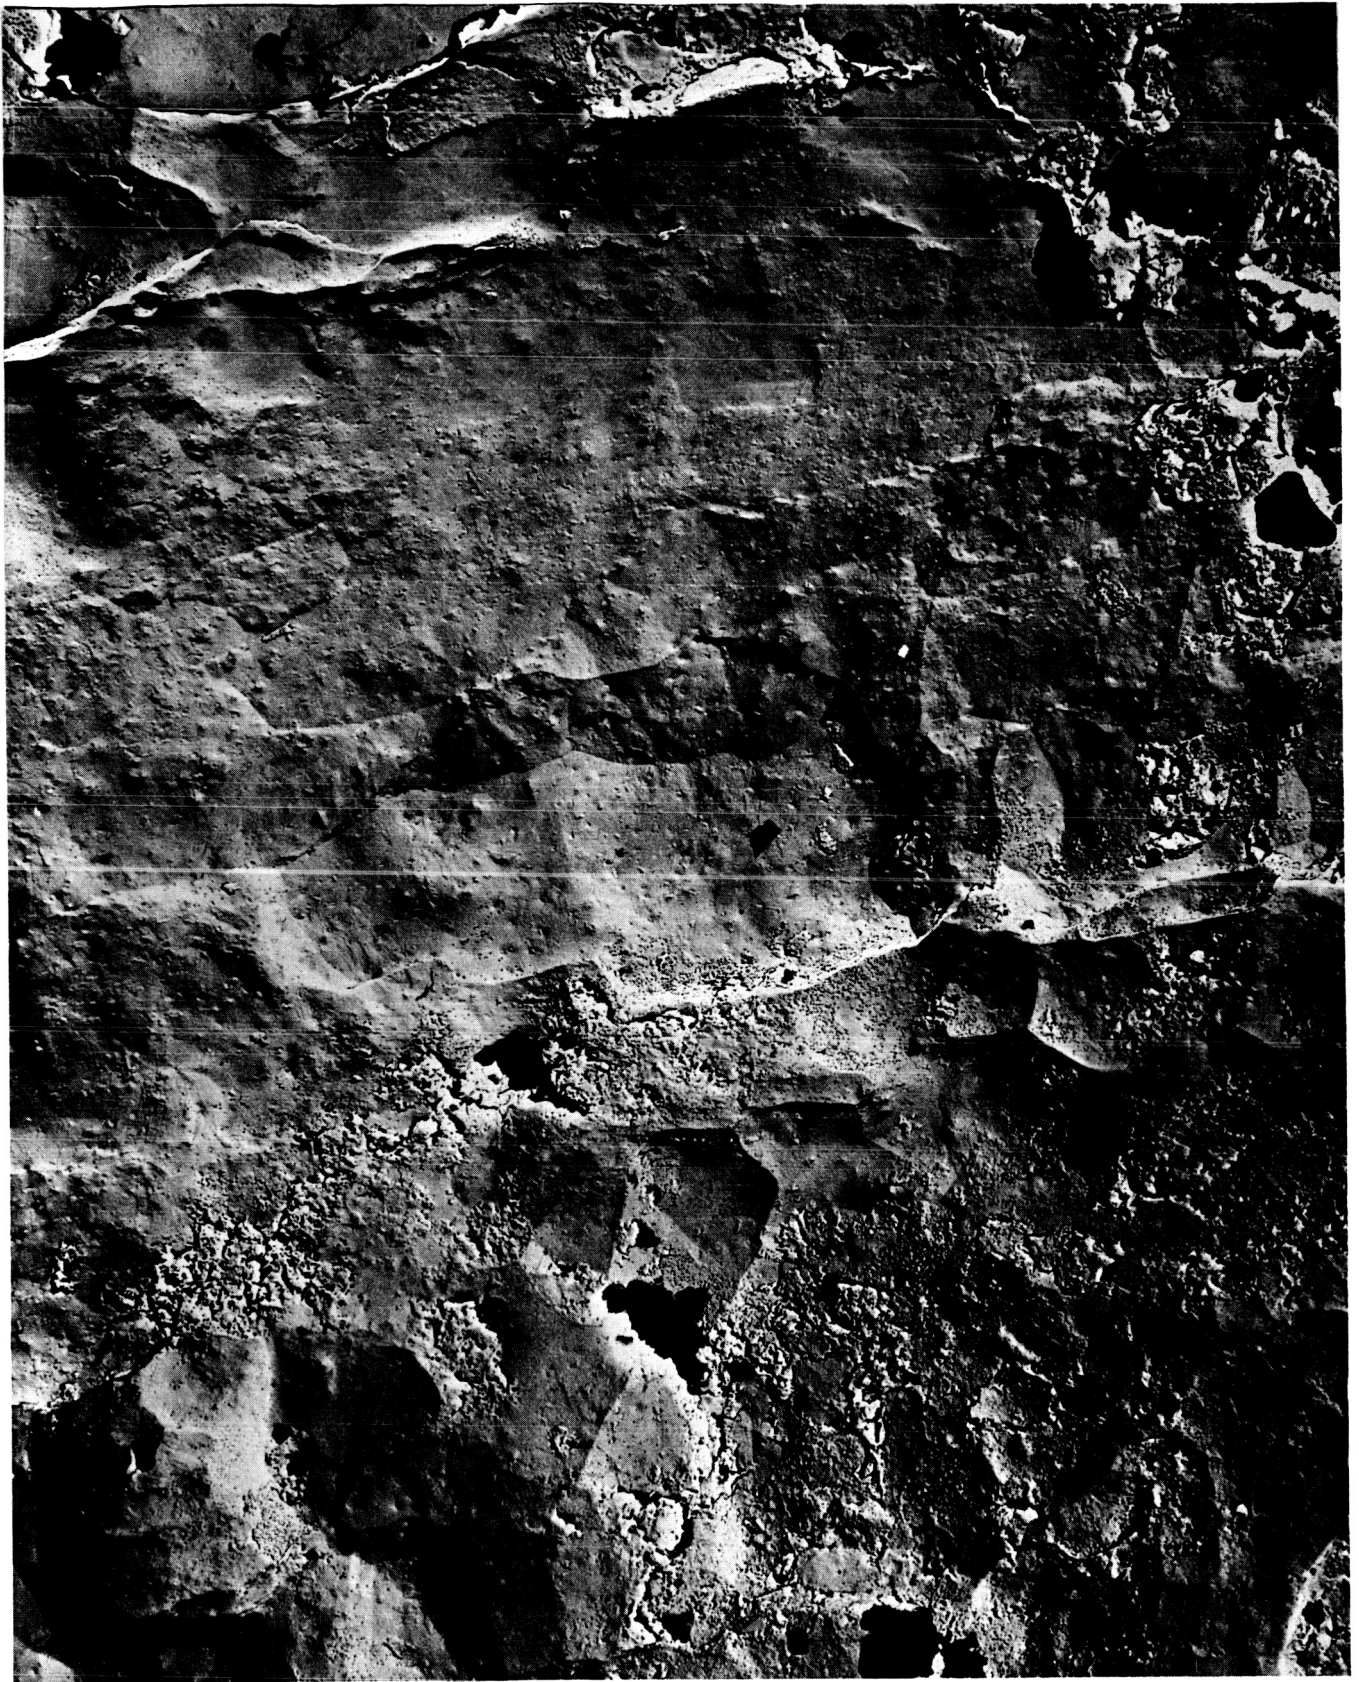
FIGURE 5

- 4) A specimen of the primary fracture was forwarded to the Aerospace Division M&P laboratories for electron microscope fractographic analysis. This analysis confirmed the original analysis that the mode of failure was stress corrosion.

4400X ELECTRON PHOTO MICROGRAPH OF FAILED ANGLE FRACTURE FACE SHOWING CORROSION AND INTERGRANULAR FAILURE.

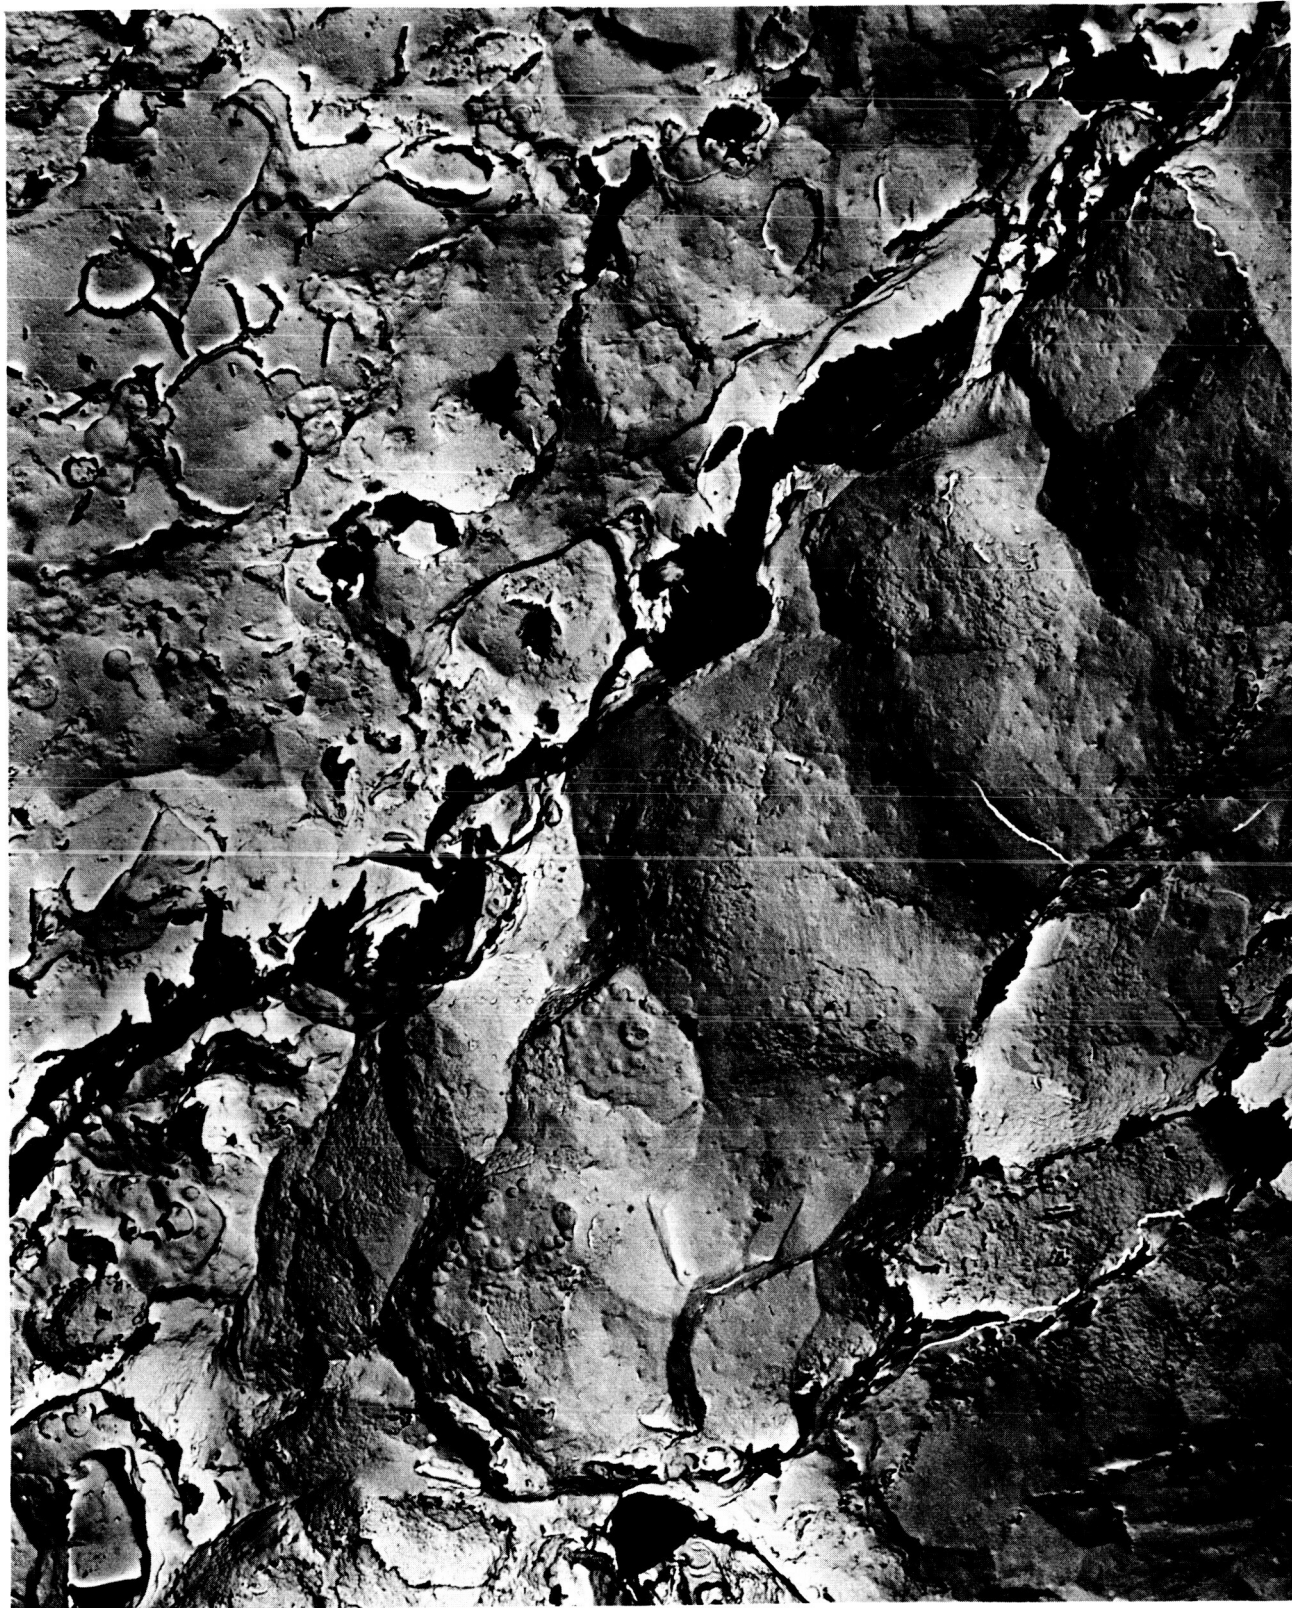
FIGURE 6

4400X ELECTRON PHOTOMICROGRAPH OF FAILED ANGLE FRACTURE FACE SHOWING
INTER GRANULAR FAILURE AND SECONDARY CRACKING.
